# PIKE PLACE MARKET PC-1S ELEVATOR DESIGN AND STAIR UPGRADE

## REVIEW OF DESIGN OPTIONS AND DECISIONS

### PC-1S ELEVATOR REPLACEMENT AND SOUTHWEST STAIR UPGRADES

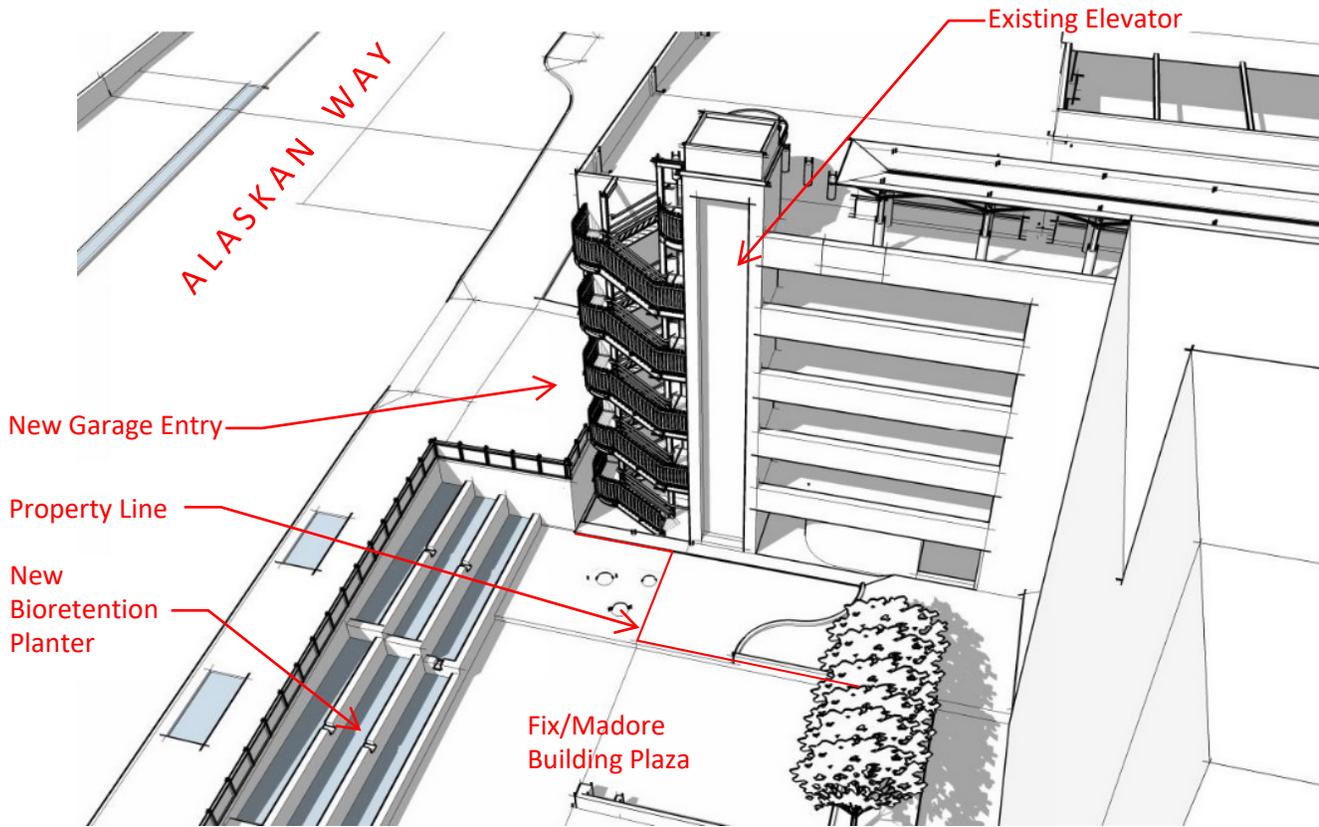
### OVERHEAD VIEW - EXISTING ELEVATOR AND STAIR

Sketch showing existing base condition after completion of Alaskan Way Improvements – with no changes shown for stair or elevator.

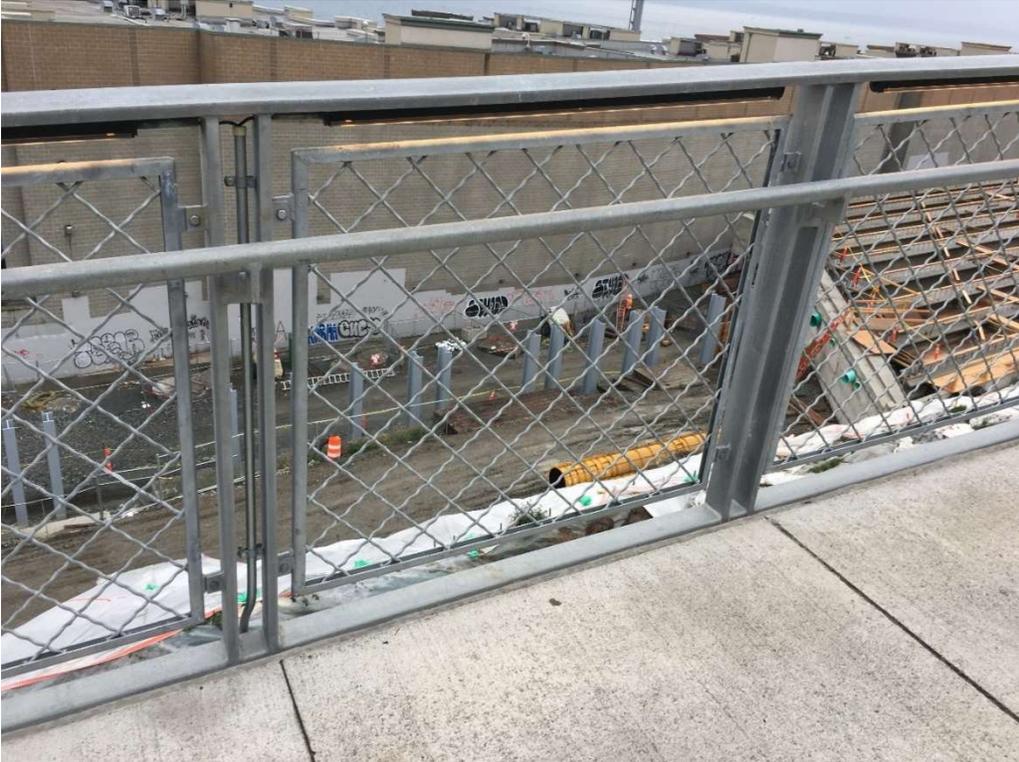
Typical screen railing at overlook.

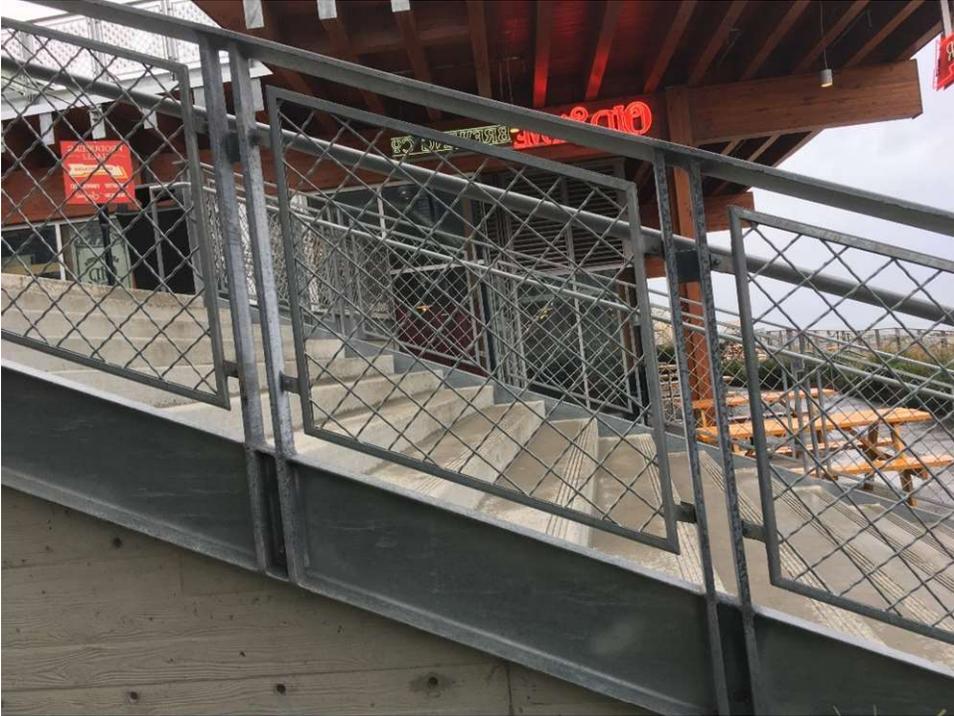
Screen railing at stair.

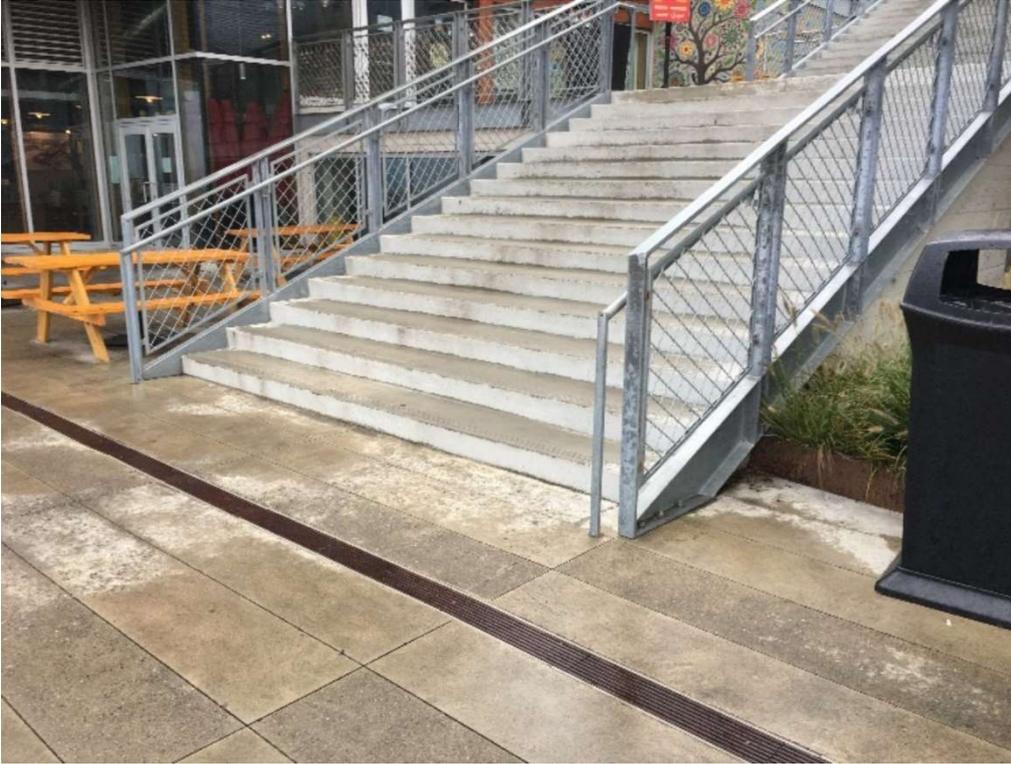
Screen railing at stair.

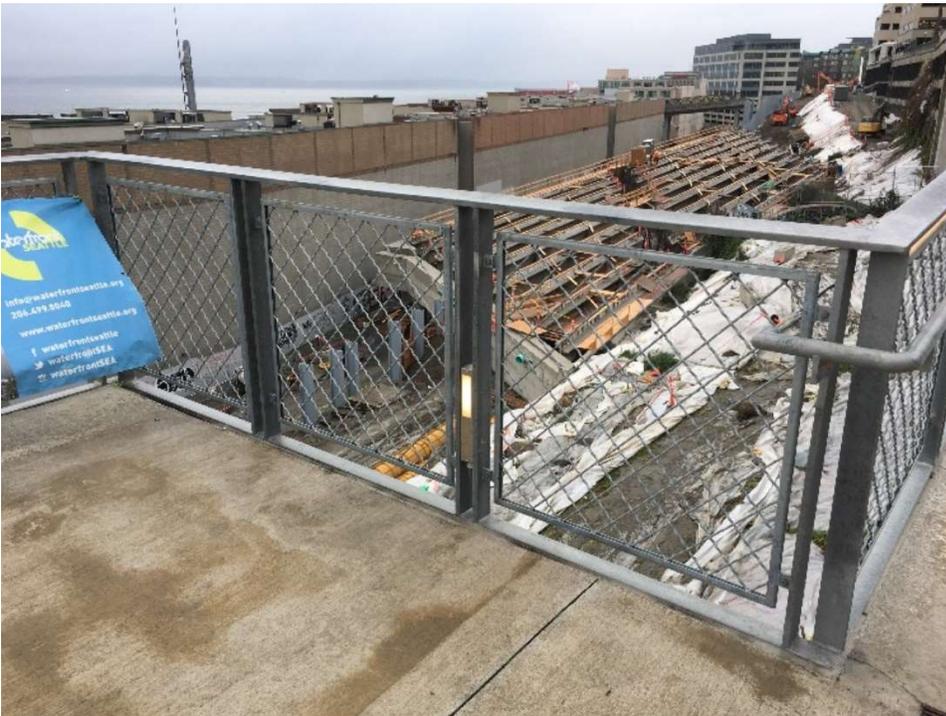
Screen railing at overlook.

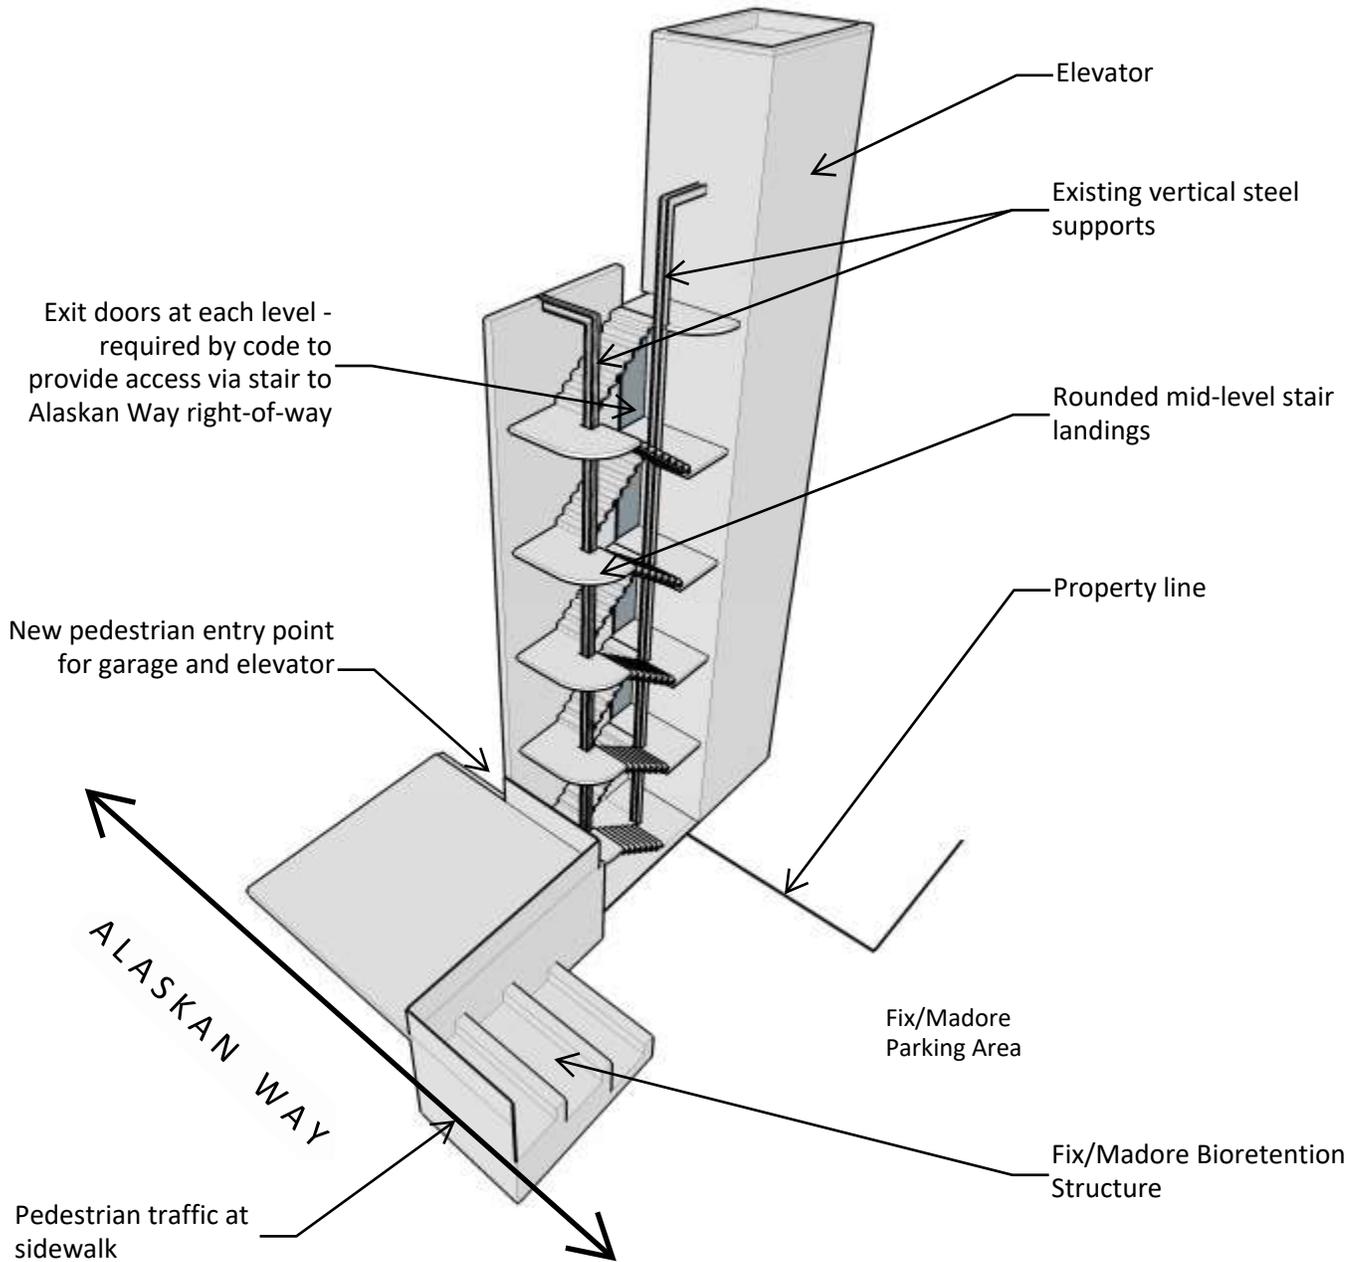
## EXISTING CONDITIONS

Diagram showing base condition with existing stair extending to Level 1 with no connection to Alaskan Way.

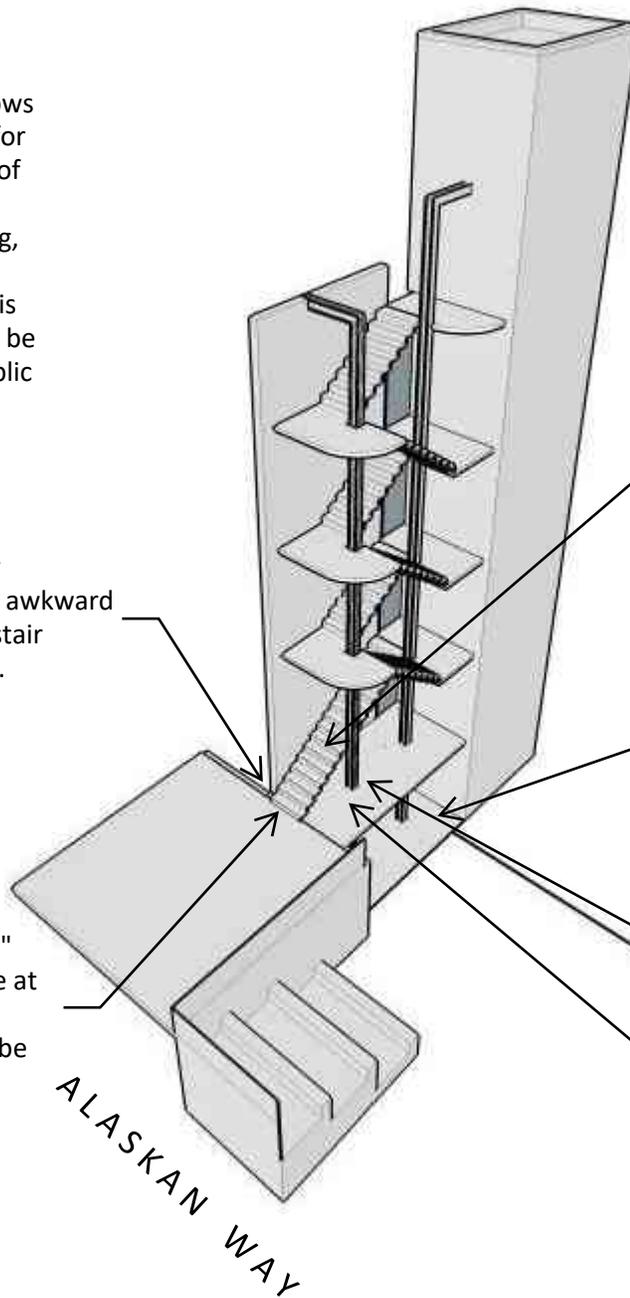
## OPTION 1

Adjacency of stair extension creates awkward condition where stair projects past wall.

Stair extends approximately 12" over property line at right-of-way - easement would be required.

New extension of stair from Level 2 to Level 3 (10 feet vertical in a continuous run)

Existing stair access to grade at Fix/Madore parking area removed  
The area below landing becomes a storage area.

New concrete deck and railing

Access to Alaskan Way with stair in existing configuration.

**Option 1** proposes minimal modifications to the overall stair layout, maintaining the existing circulation design and extends the stair in a straight run from Level 3 to Level 2, landing at the sidewalk along Alaskan Way. The existing stair above Level 3 is to remain intact. The Seattle Building Code allows for 12 feet (vertical) of continuous run of stairs before a landing is required. Because the existing floor-to-floor dimension at the garage is 10 feet, the new stair section complies with the code. The new stair landing at the sidewalk would be adjacent to the south wall of the garage, and extend into the right of way by approximately 12 inches. For this option, the proximity of the stair to the interior garage entry creates a problematic and awkward relationship between the stair and entry to the garage by extending past the wall (see graphics).

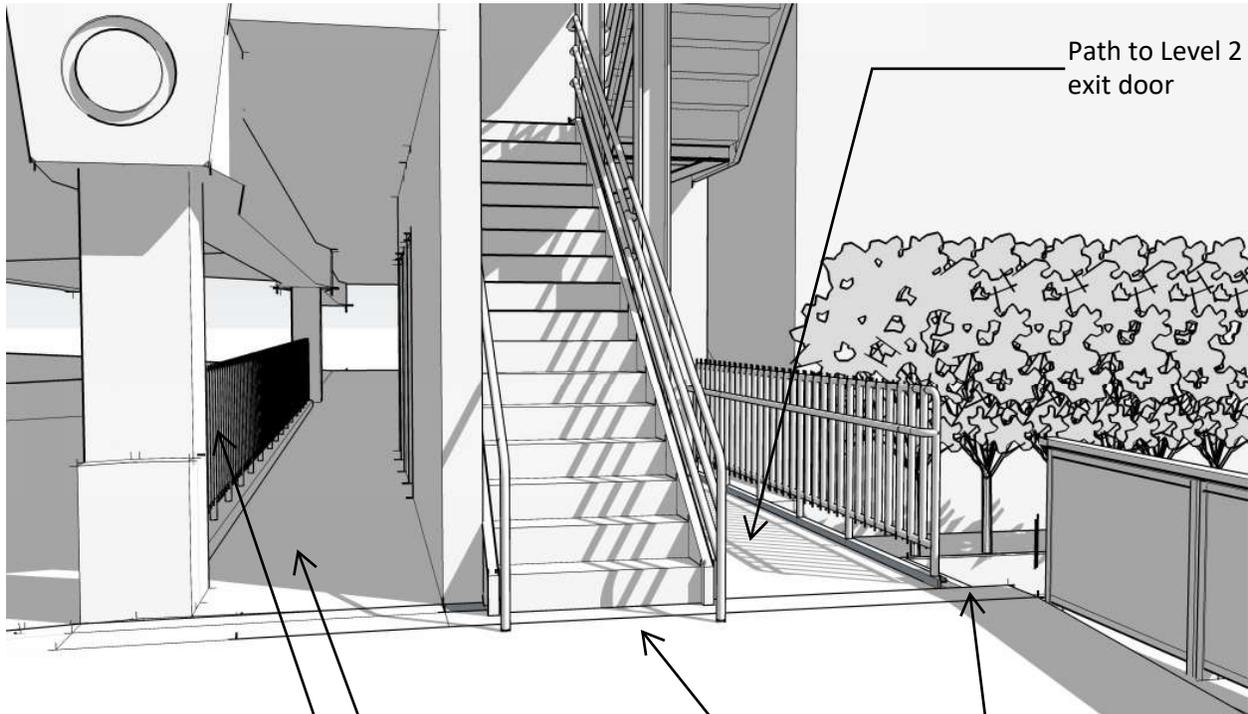
**OPTION 1**

Path to Level 2  
exit door

Note the gap created by the  
alignment of the garage  
railing at the property line  
and the location of the  
railing at the bioretention  
wall - this would need to be  
resolved.

New steel pipe railing to match  
existing stair railing to be  
installed at this location by  
Garage Project

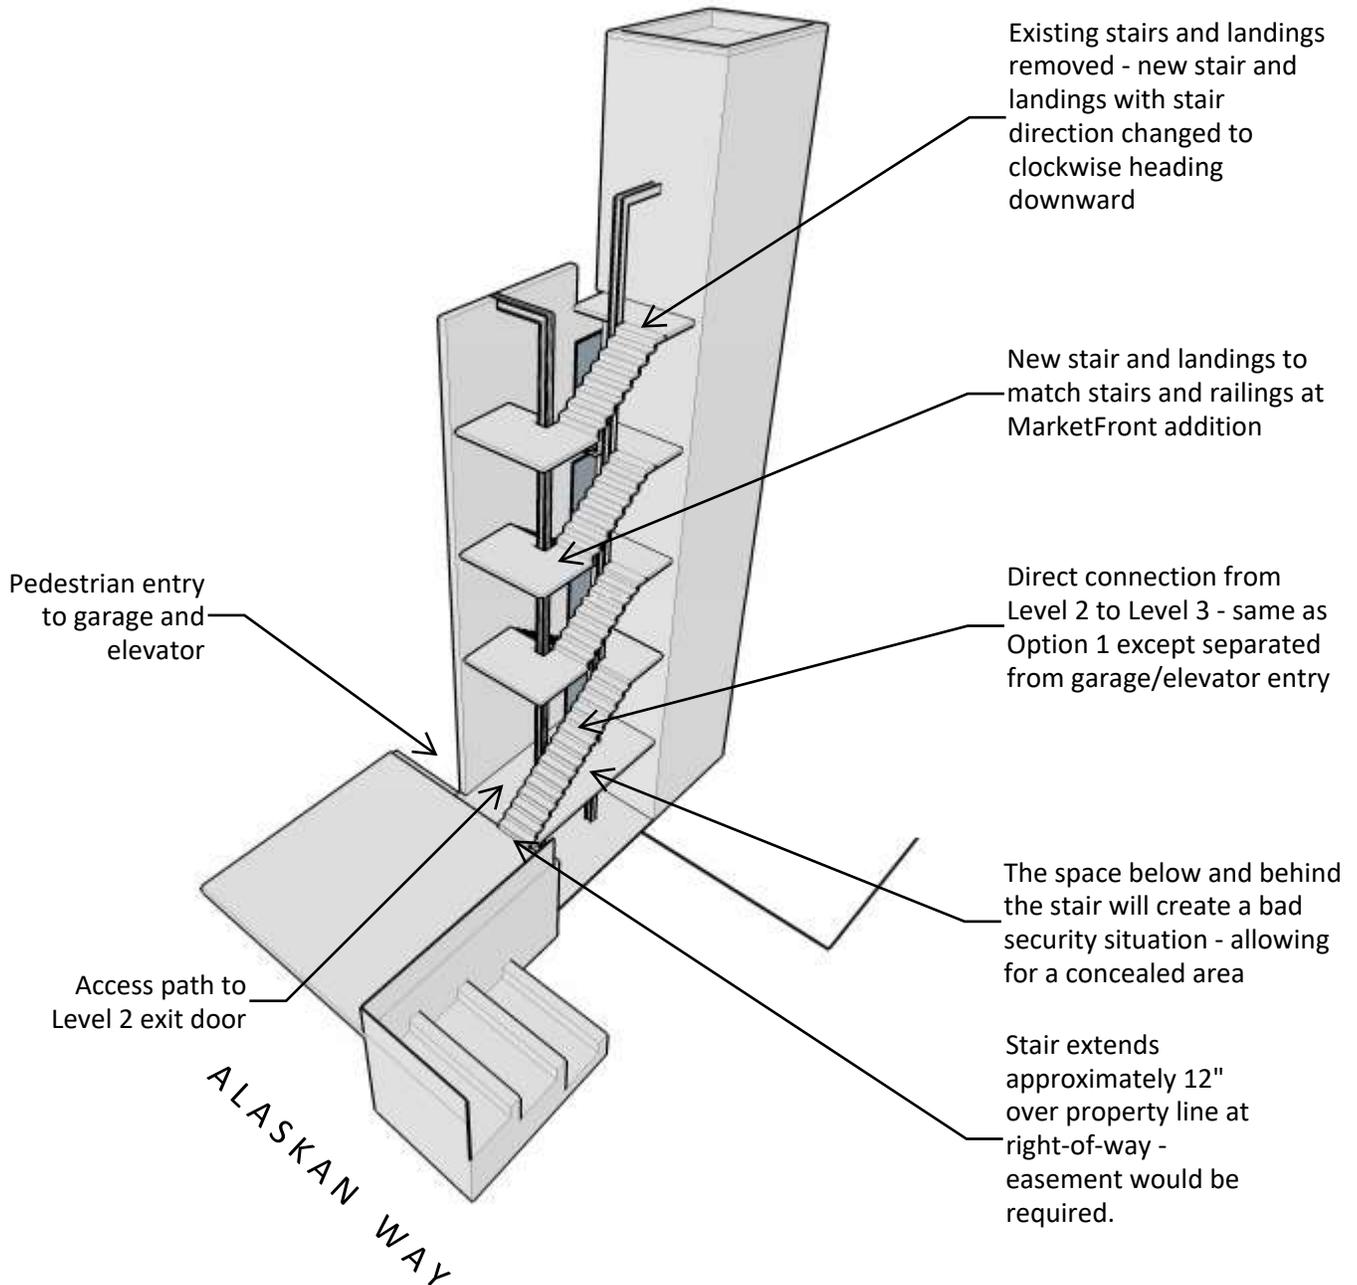
## OPTION 2

Change stair direction, with new stair construction to match MarketFront stair vocabulary.

The new stair is complies with the building code, and is separated from the garage entry.

**Option 2** used the same extension concept described in Option 1 (straight run from Level 3 to Level 2), but switched the stair direction to allow for the extension from Level 3 to Level 2 be separated from the interior garage entry. This design resolves the stair/entry issues created in Option 1. This design meets Seattle Building Code standards.

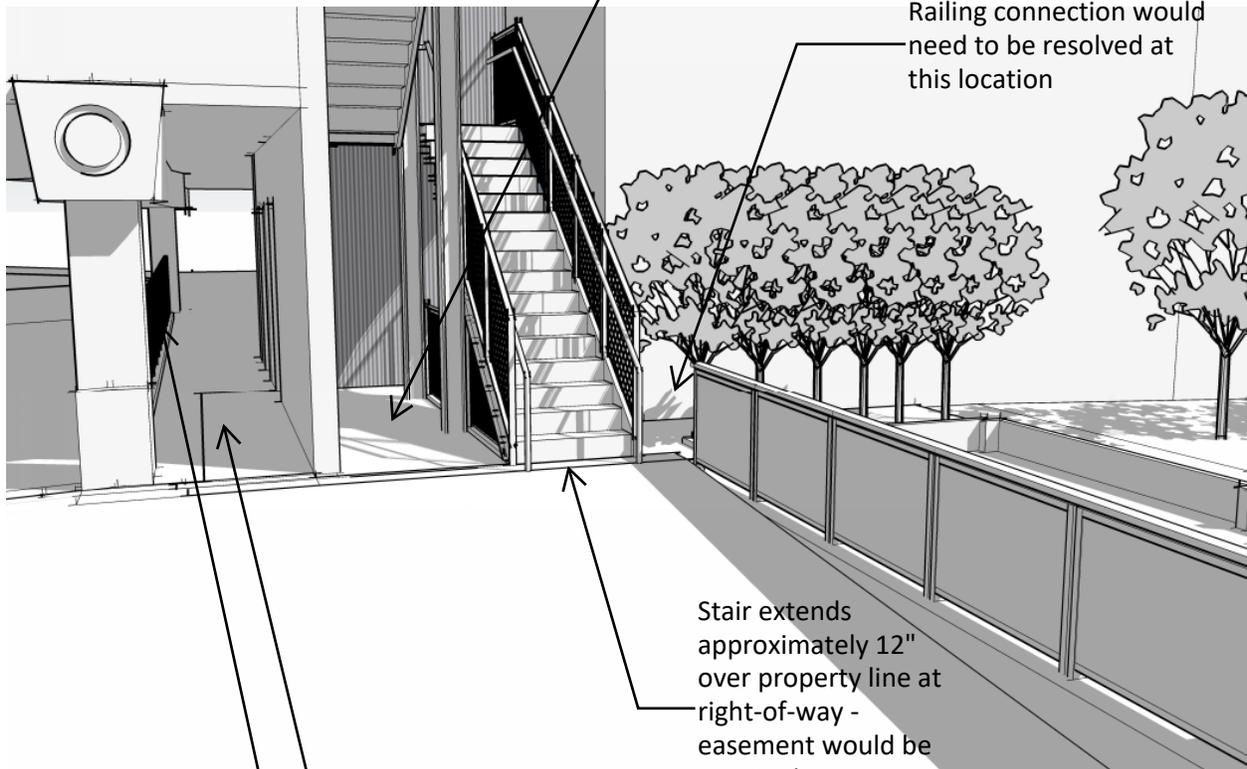
**OPTION 2**

Path to Level 2  
exit door

Railing connection would  
need to be resolved at  
this location

New steel pipe railing to match  
existing stair railing to be  
installed at this location by  
Garage Project

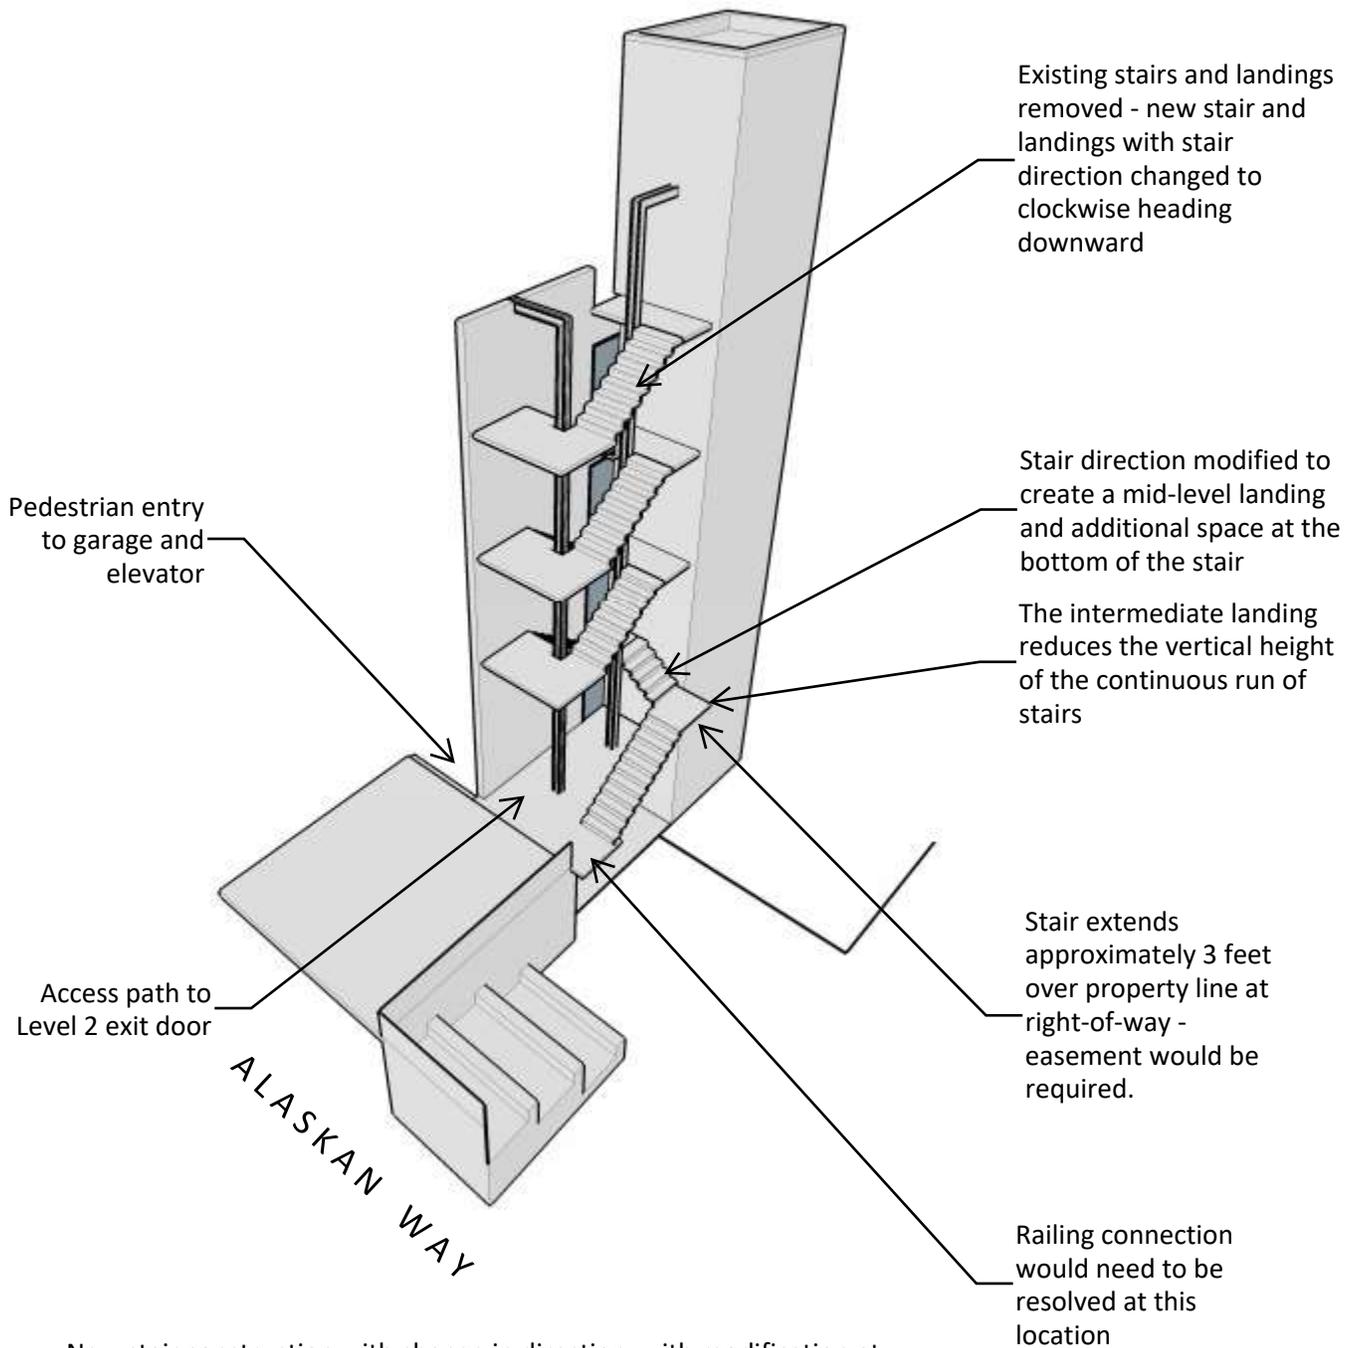
### OPTION 3

New stair construction with change in direction, with modification at Level 2 to allow start of stair to be set back from property line.

**Option 3** altered the direct stair run from Level 2 to Level 3 to provide an intermediate landing, as well as creating additional space at the new base of the stair for improved queuing and circulation. To achieve more circulation space at Alaskan Way, this design extends south over the right-of-way approximately three (3) feet to avoid the southern most steel support column supporting the stairs structures.

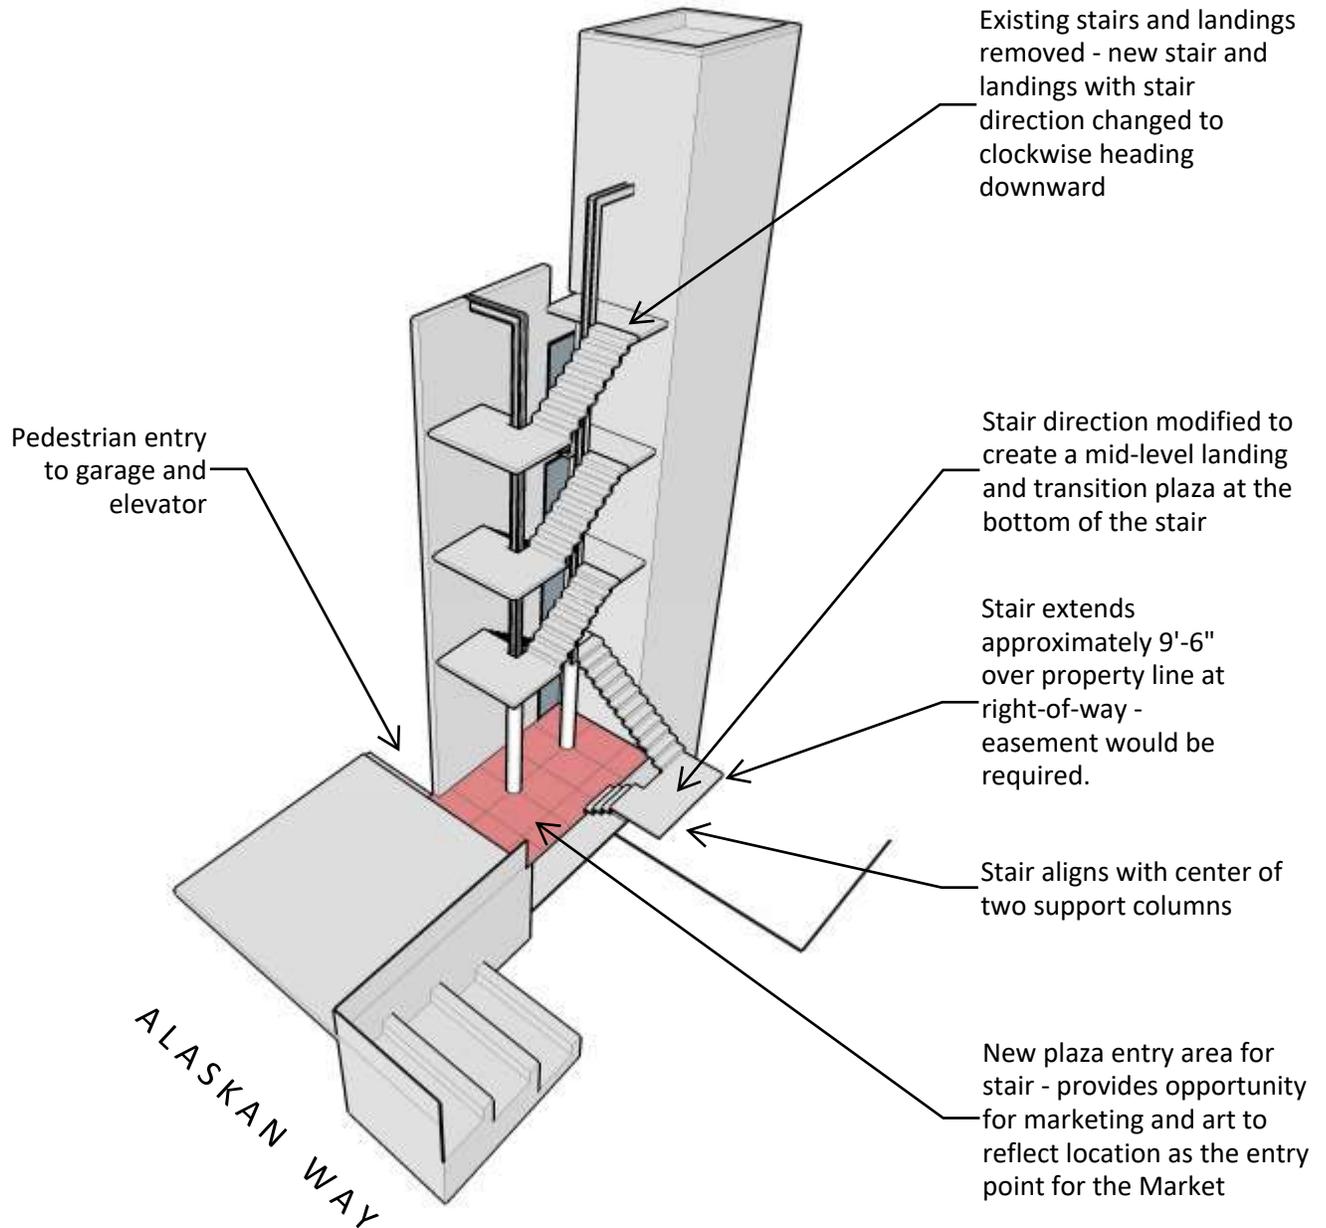
## OPTION 4

New stair construction with change in direction, with modification at Level 2 to create a stair plaza area at Level 2.

Stair length between Level 2 and 3 is reduced by new landing, which is oriented to allow for an open queuing area at the base of the stair structure.

This solution also eliminates any nooks or hidden areas that could compromise security. The area below the new landing is proposed to be physically and visually closed off.

**Option 4** seeks to open the space at the new base of the stair for queuing and circulation, a creates a small transition plaza area to serve as the symbolic entry to the Market. This design allows the new landing to better integrate with the sidewalk at Alaskan Way, by extending over the right of way approximately 9-and-half feet, and matches up with the east-west run of the new bioretention wall and railing. This creates a more open and seamless connecting plaza, and eliminates constrained spaces created by stair overhangs. The wider plaza space allows the Pike Place Market an opportunity to create invitation to the Market by activating the space with Market related graphics or art.

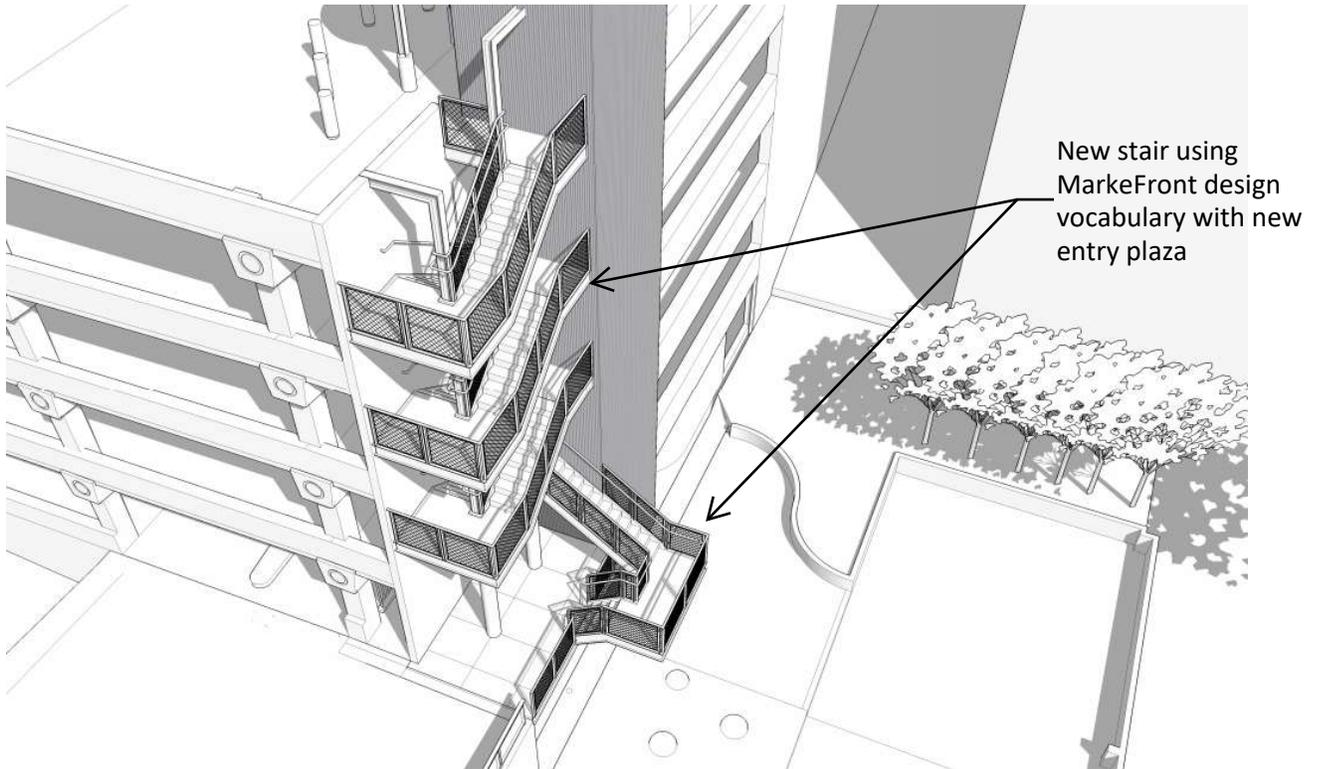
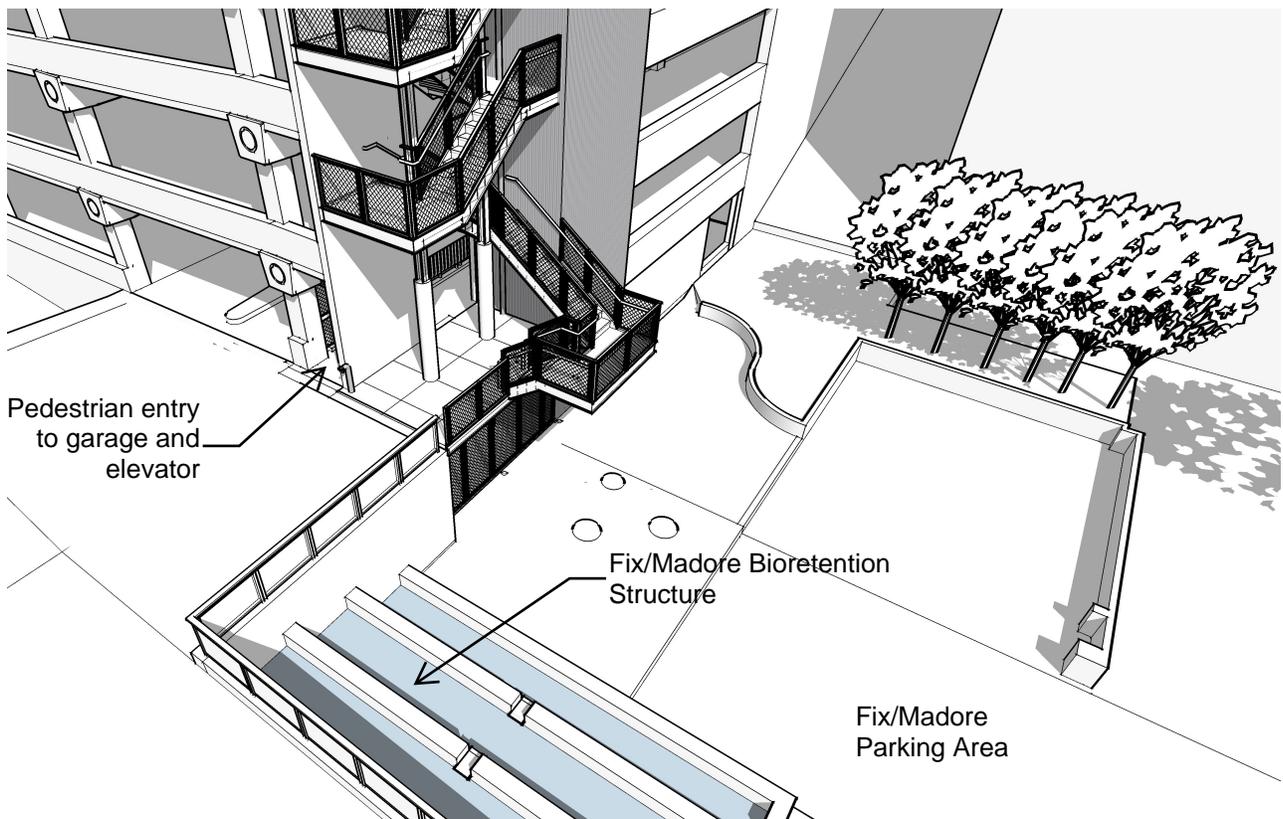
OPTION 4

Vertical steel columns  
shown with concrete  
column surround to  
provide significance for  
entry area

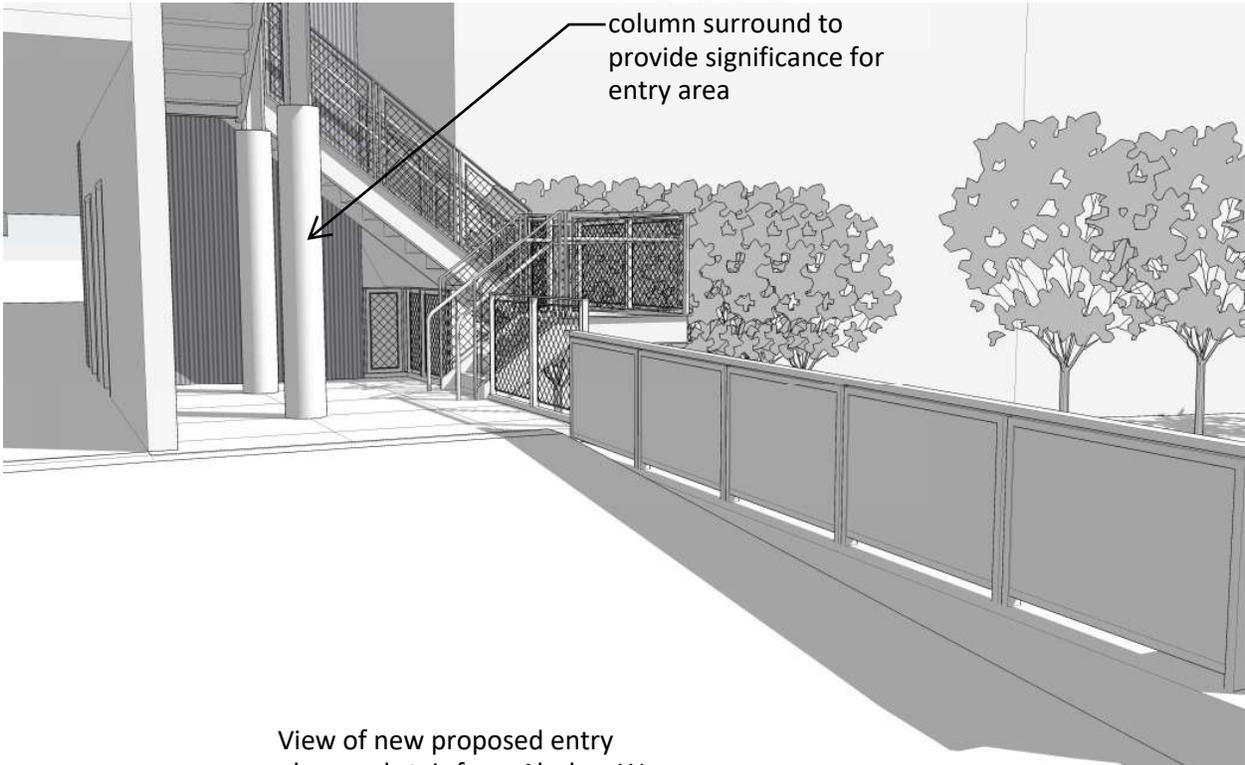
View of new proposed entry  
plaza and stair from Alaskan Way
